# CALIBER Home Inspections

555 Sunny Day Dr  
San Diego, CA 91234

Prepared for: Sample

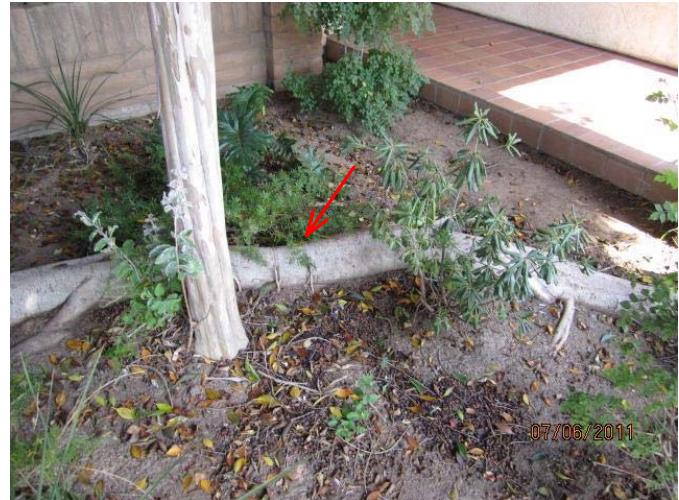
#2 Tree roots can cause foundation problems

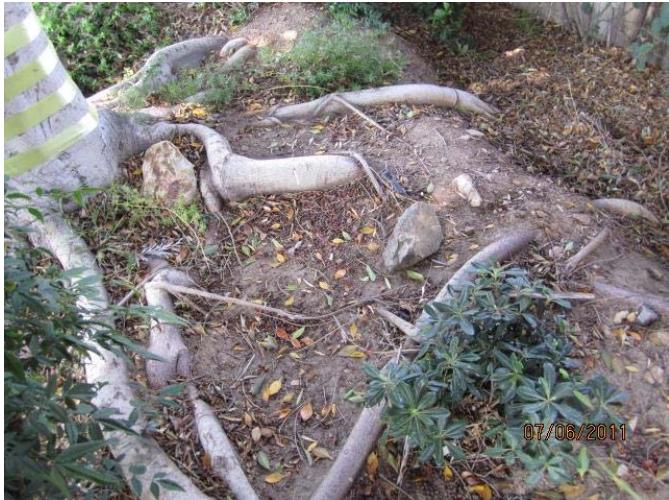
#3 Tree roots can cause foundation problems

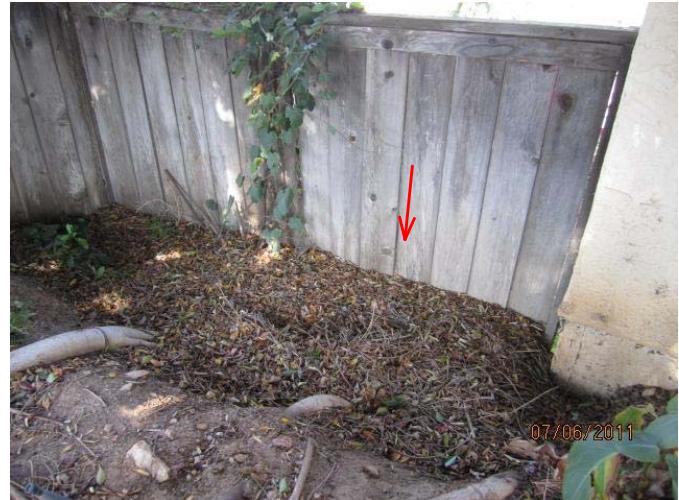
#4 Wood fence is rotting due to poor drainage

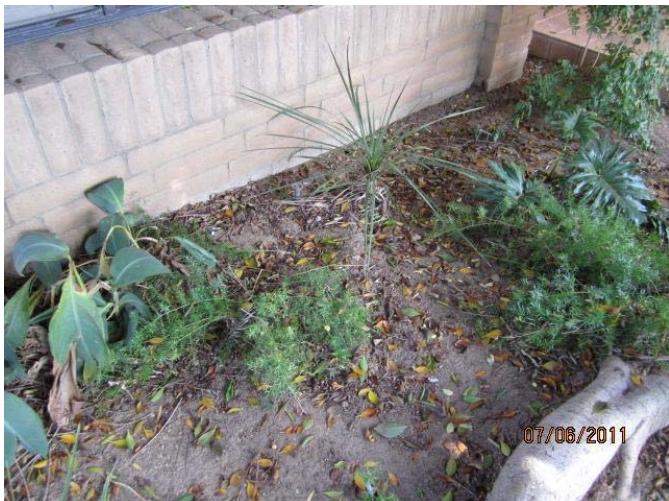
#5 No drainage located at front of house, recommend improving grading

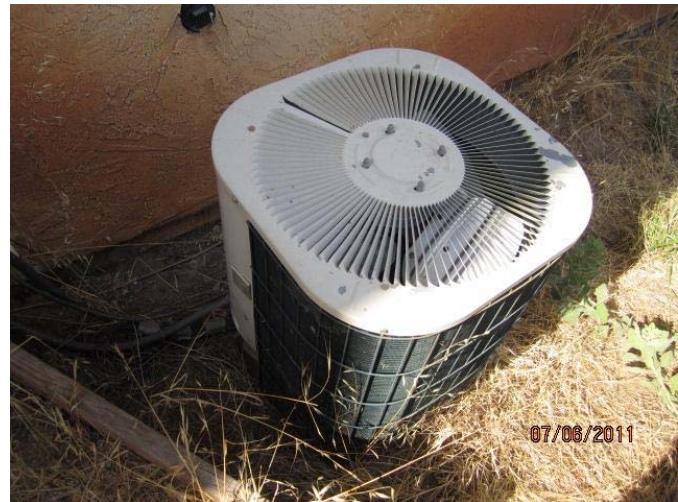
22. Main AC System Refrigerant Lines: Serviceable condition **AC line insulation needs to be replaced**

#15 AC line insulation needs to be replaced

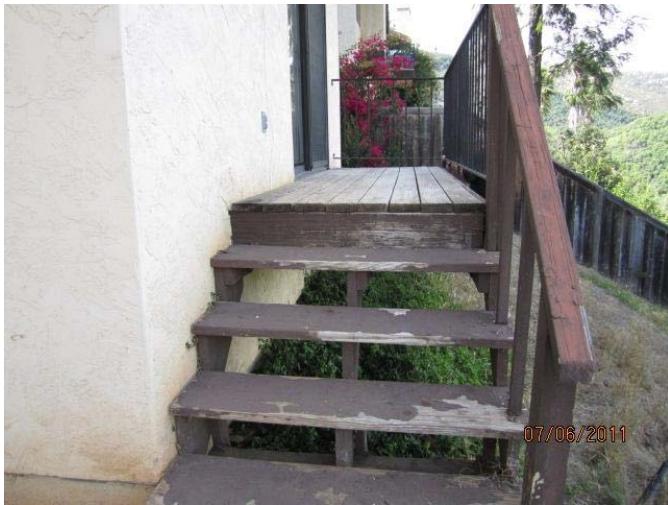
#20 Wood deck should be re-built due to wood rot

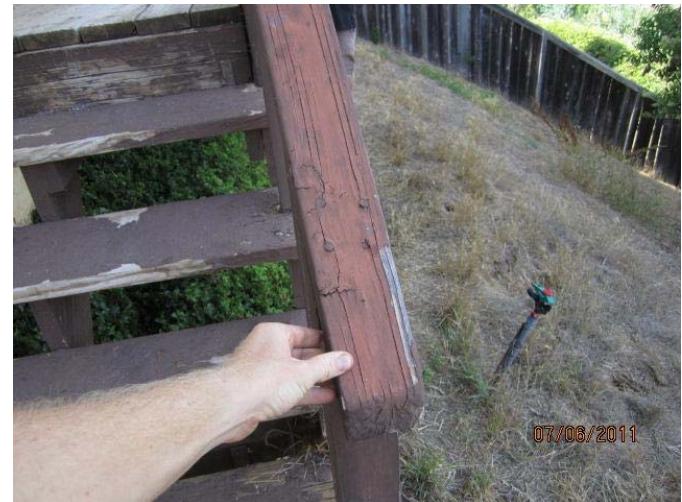
#21 Wood deck should be re-built due to wood rot

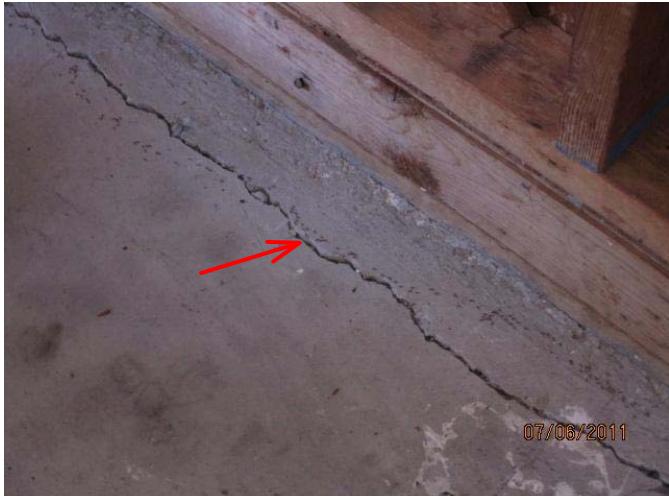
#28 Garage floor cracks noted

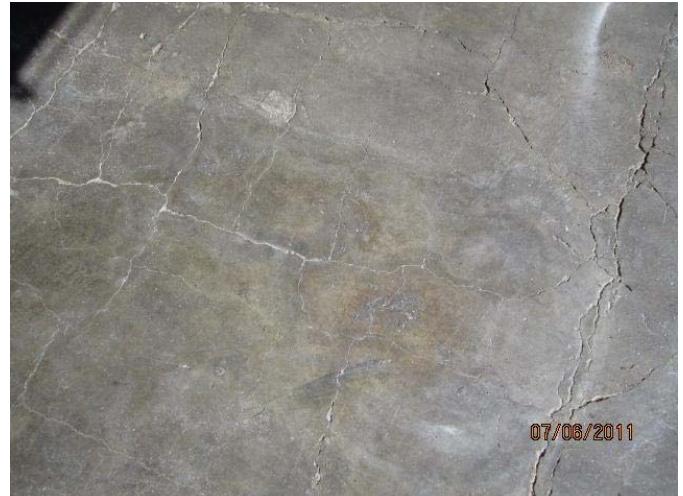
#29 Garage floor cracks noted

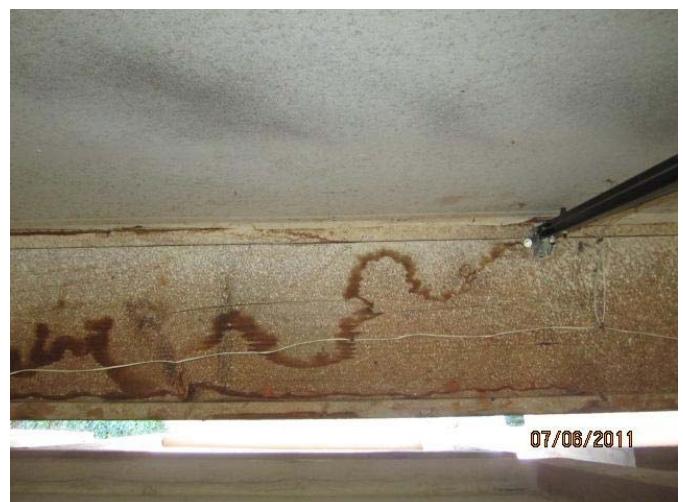
#31 Garage door has water damage

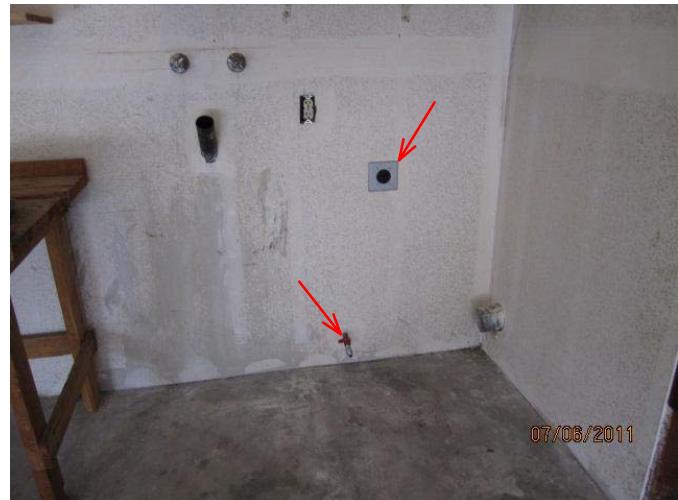
#33 Missing outlet cover plate at laundry area

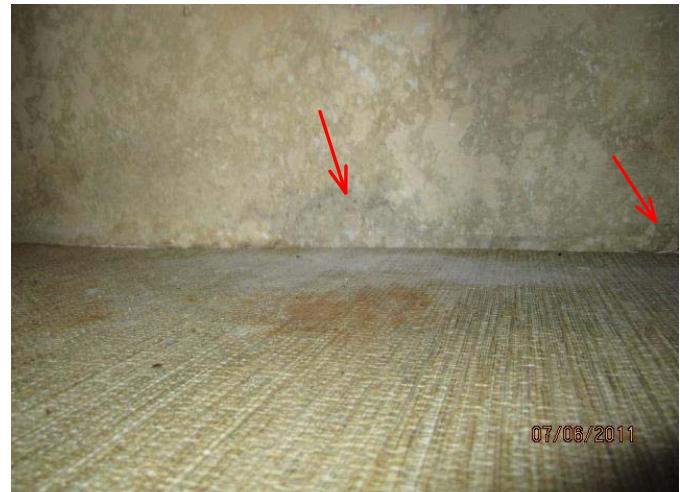
#51 Moisture stains noted under sink

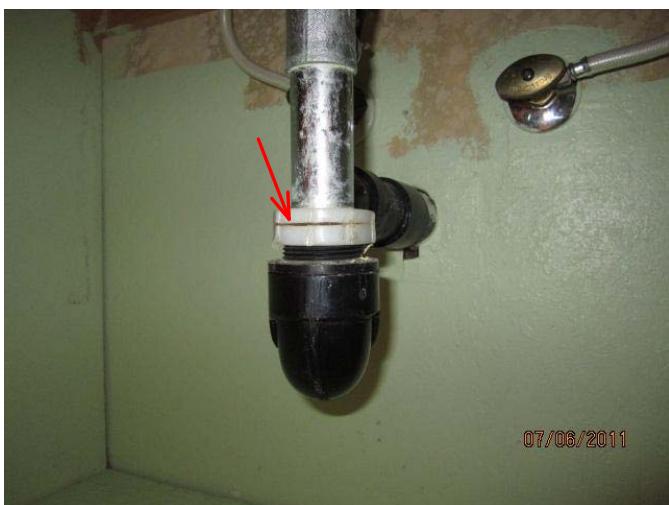
#57 Sink drain pipe connection is cracked

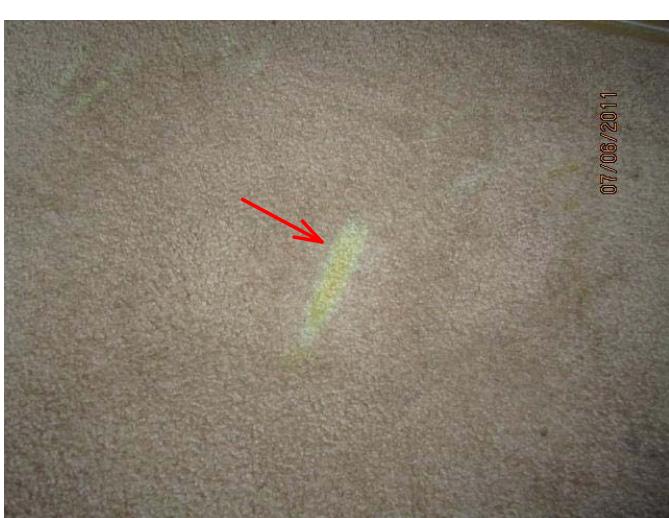
#59 Carpet stains noted

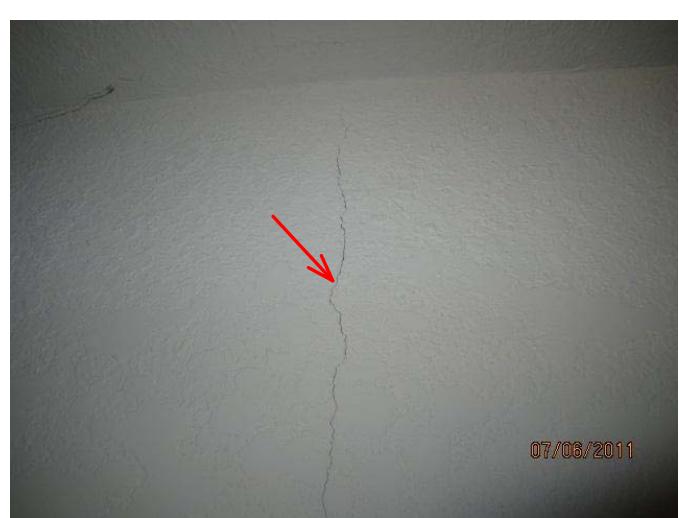
#60 Drywall cracks noted

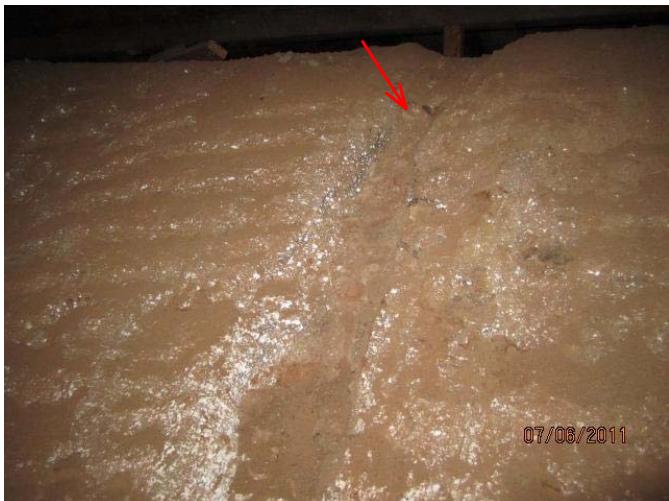
21. Moisture Penetration: Yes **Signs of water intrusion from the front foundation wall**

#63 Signs of water intrusion from the front foundation wall

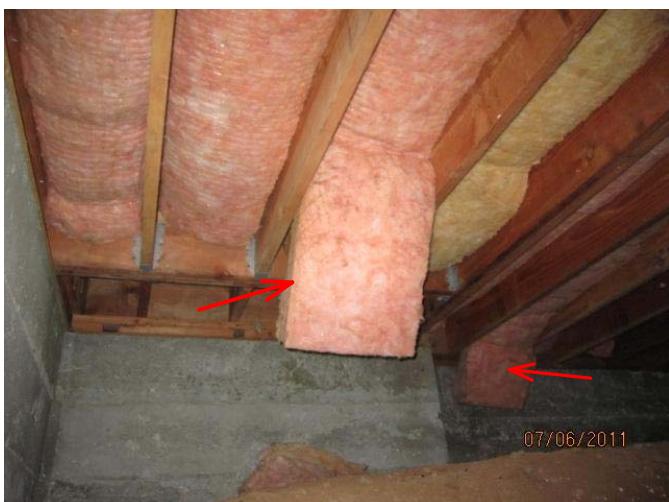
#65 Loose insulation needs to be secured

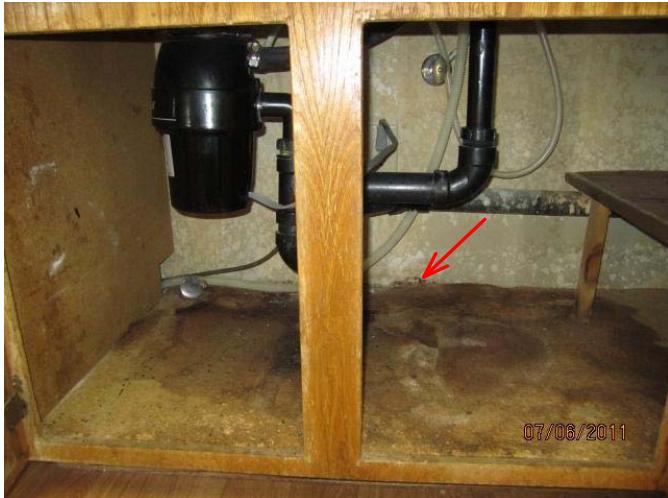
#69 Moisture damage, mold like substance noted under kitchen sink

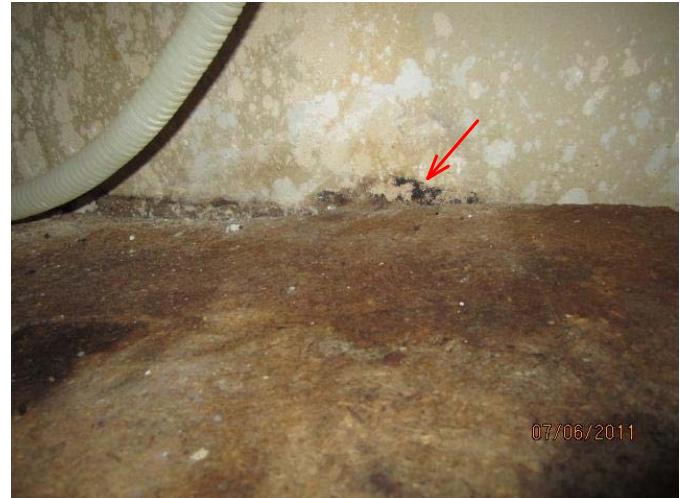
#70 Mold like substance noted under kitchen sink

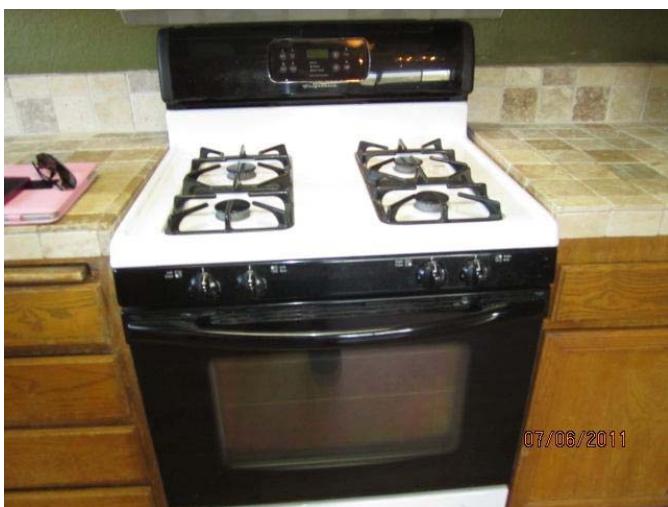
#71 The range is missing the anti-tipping device

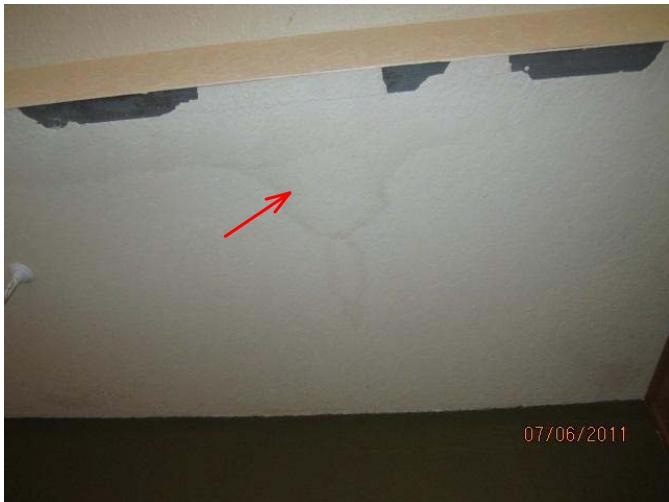
#73 Moisture stains noted to ceiling, suspect its from a roof leak

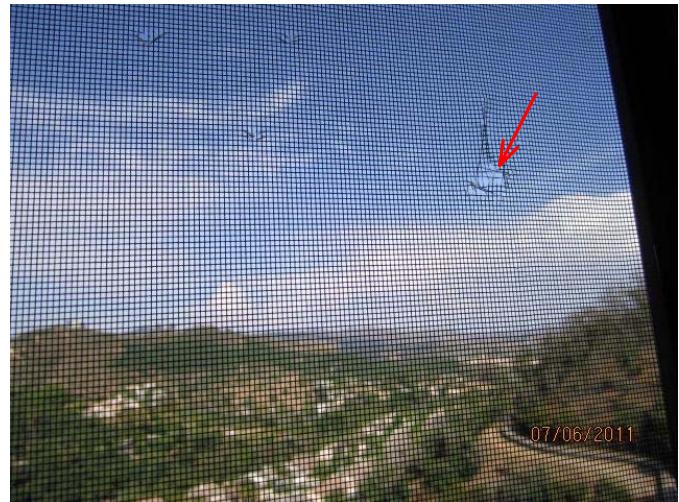
#74 Torn window screens

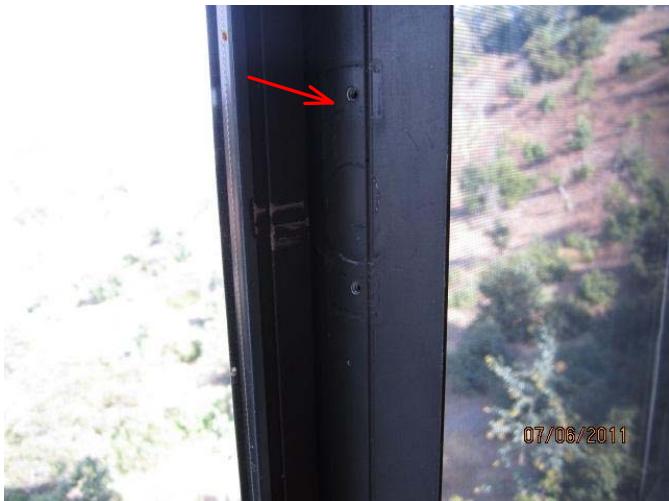
#75 Missing window hardware

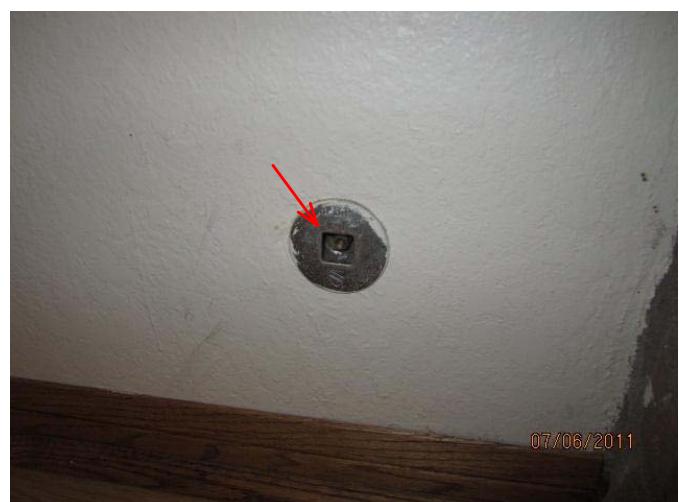
#78 Gas valve key is missing

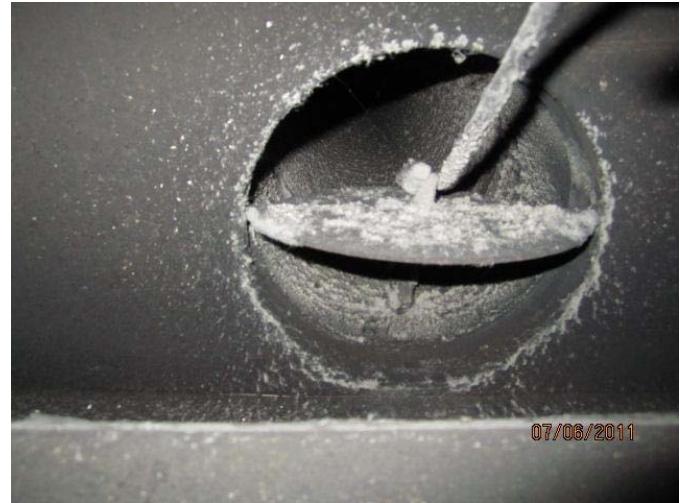
#80 Creosote build-up, recommend cleaning

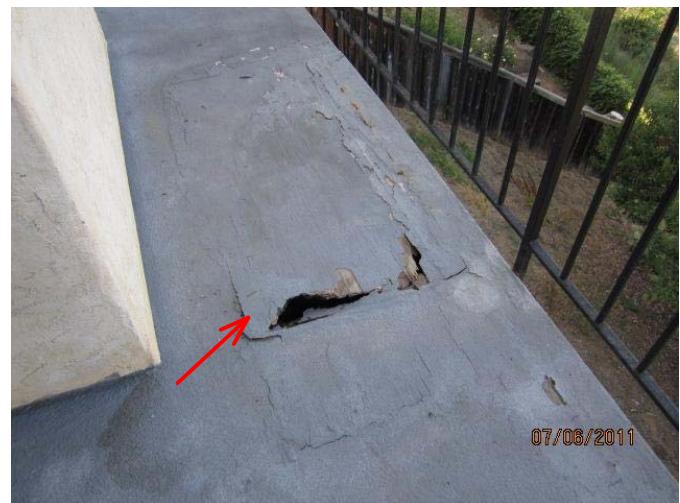
#82 Balcony has extensive rot and is not safe to walk on

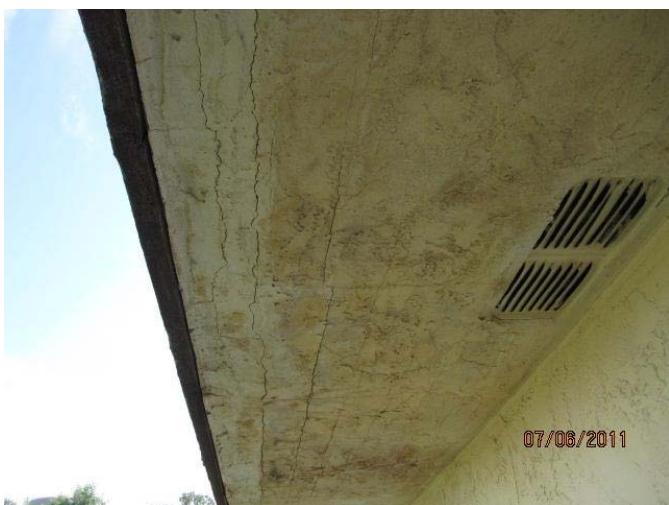
#83 Moisture damage to under side of upper deck due to wood rot

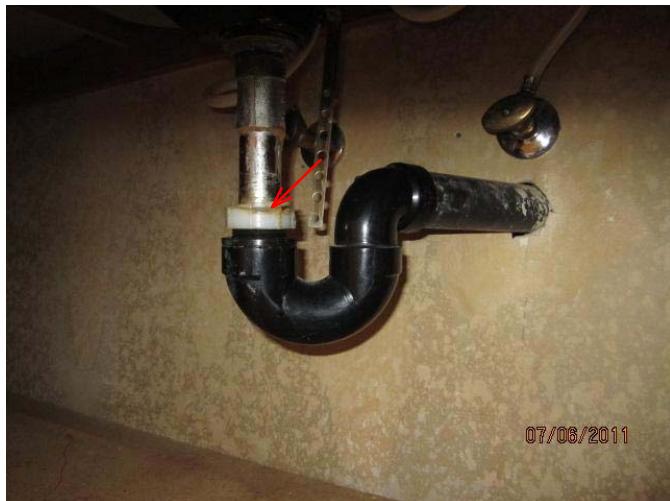
#87 Drain pipe connection is cracked

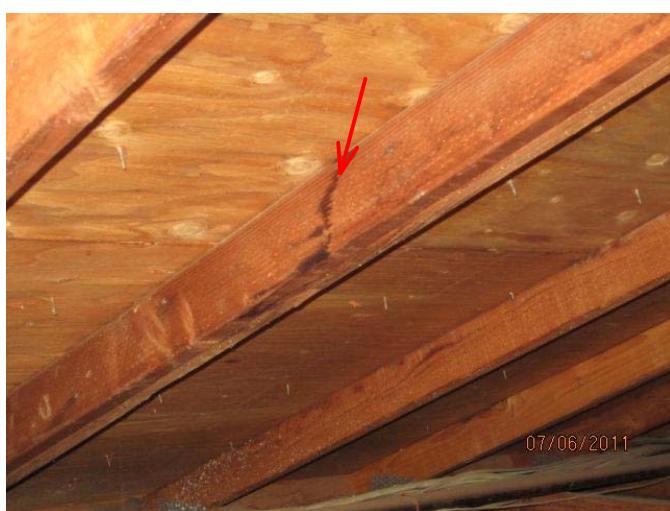
#89 Excess moisture stains noted

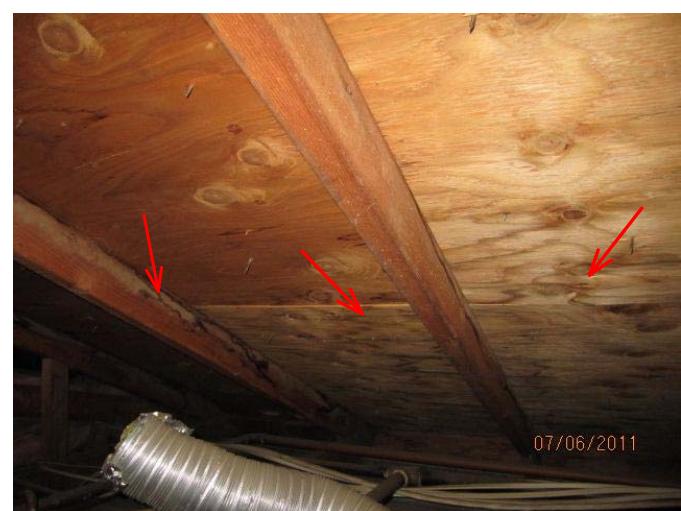
#90 Excess moisture stains noted

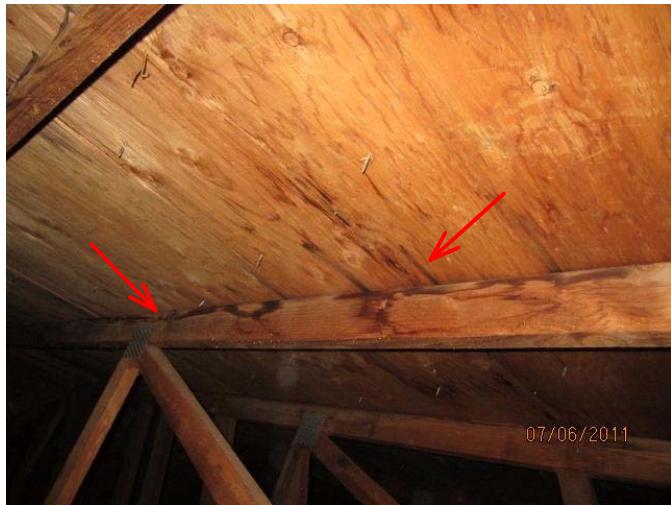
#91 Excess moisture stains noted

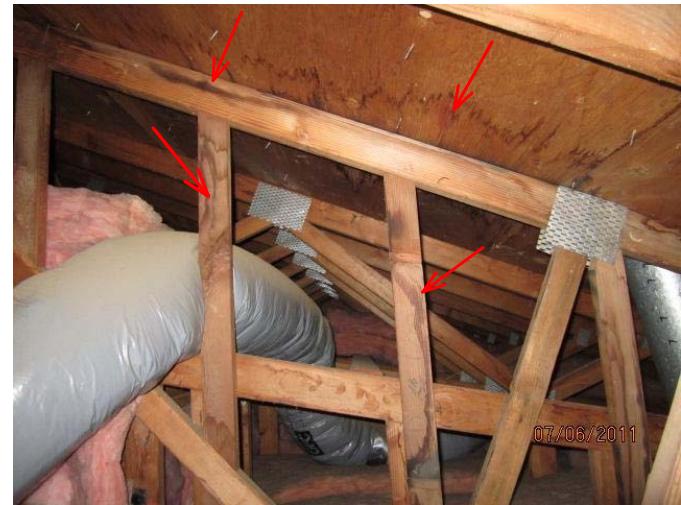
#92 Excess moisture stains noted
