# CALIBER Home Inspections

555 Sunny Day Dr  
San Diego, CA 91234

Prepared for: Sample

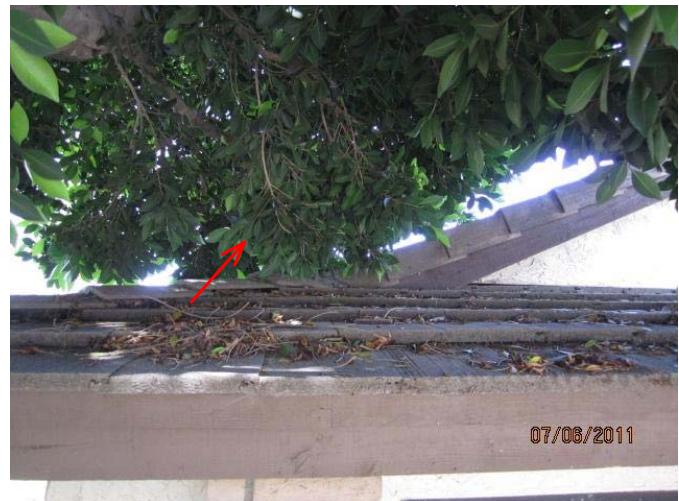
#6 Trees should be cut back from the roof

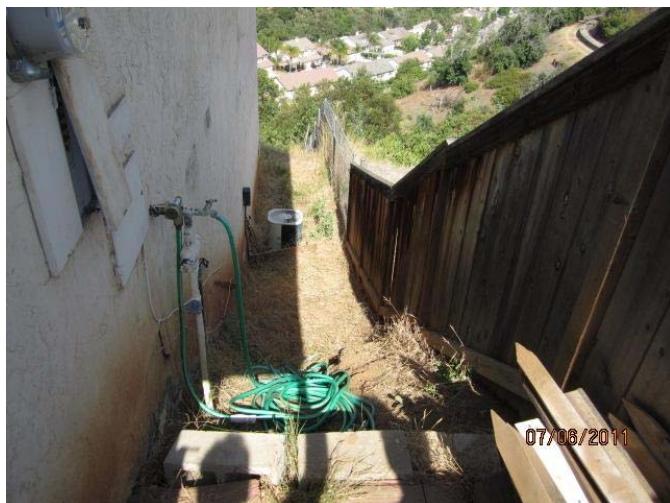
#11 Side yard needs steps and proper drainage

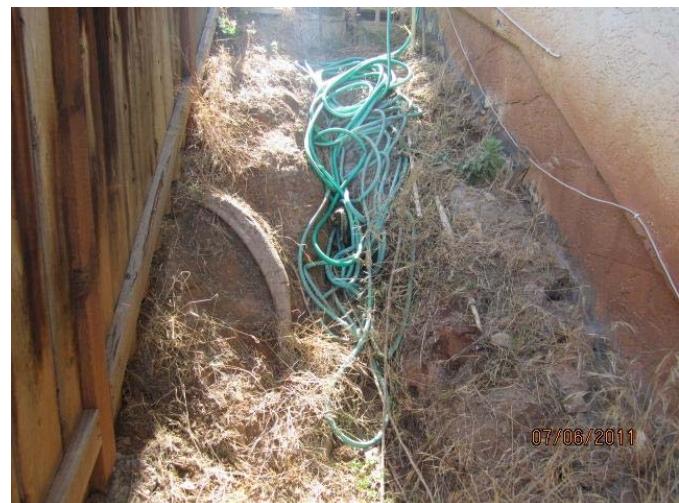
#12 Side yard needs steps and proper drainage

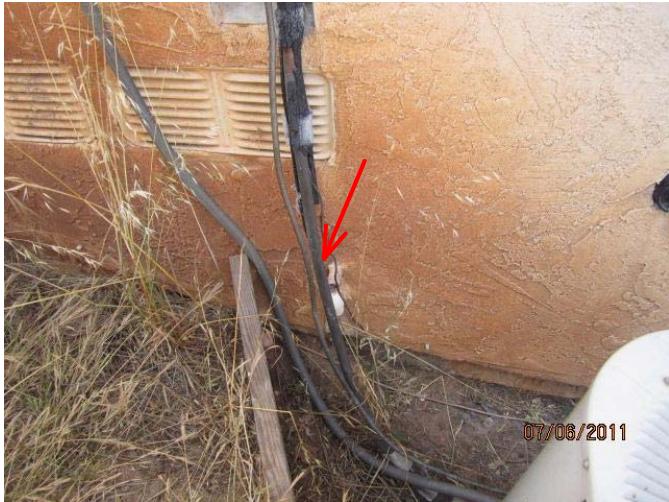
#15 AC line insulation needs to be replaced

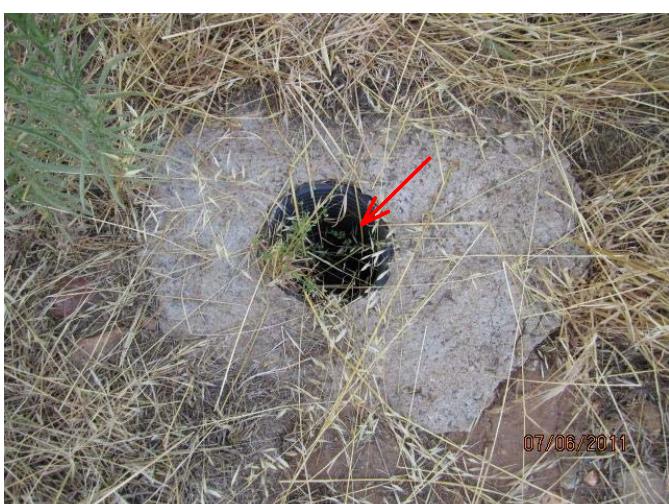
#17 Surface drains need covers

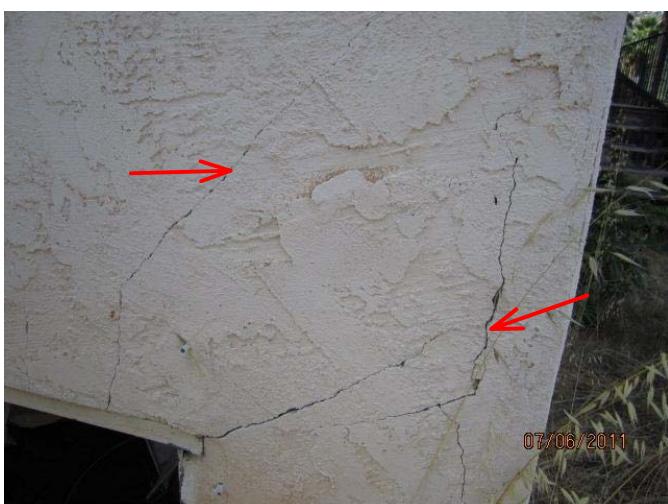
3. Exterior Surface Type: Stucco **Water stains indicate the roof may be leaking, Stucco cracks need repair**
4. Windows: Aluminum **Missing window hardware**
5. Window Screens: Vinyl mesh **Window screens are damaged, Missing window screens**

#23 Stucco cracks need repair

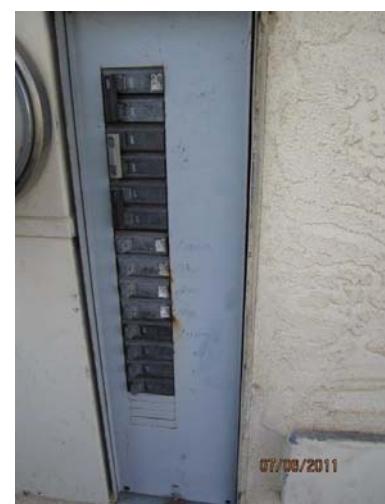
12. Recessed in wall - Outside Electric Panel Manufacturer: Square D **Panel cover hinges need repair**

#24 Main Electrical  
Panel cover hinges need repair

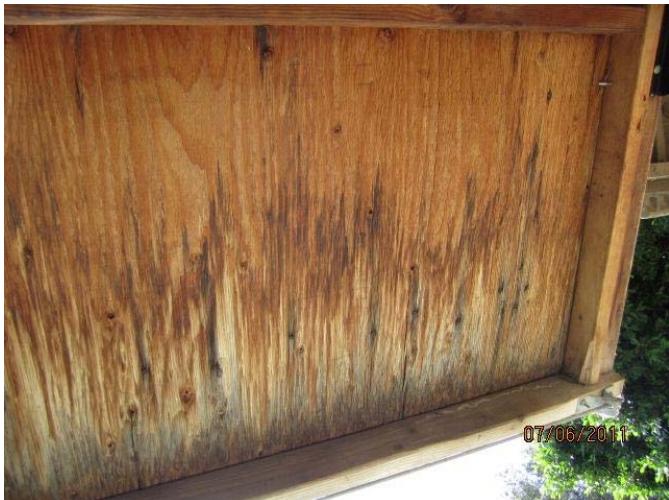
#31 Garage door has water damage

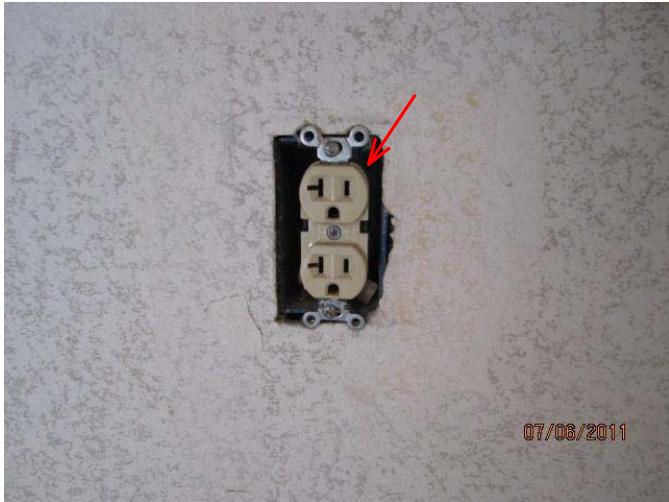
11. 120 VAC Outlets: Grounded **Missing outlet cover plates**

#33 Missing outlet cover plate at laundry area

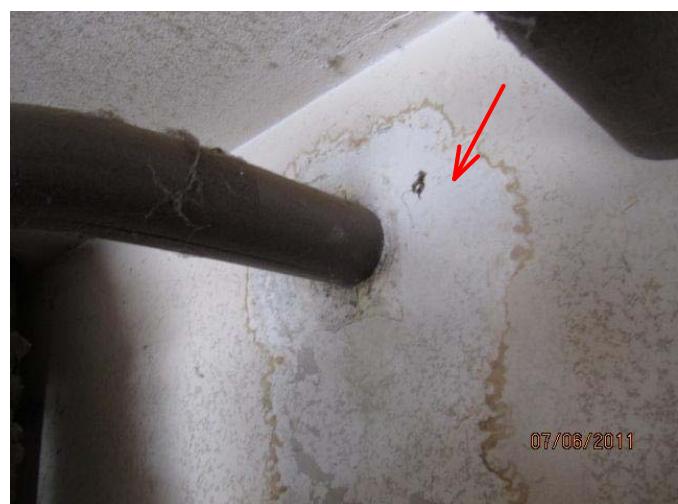
#36 Water stains, suspect a past leak as it's currently  
dry

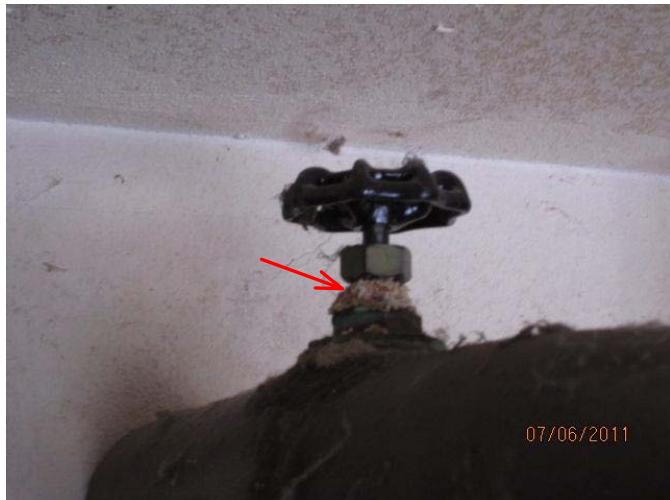
#37 Tank isolation valve needs to be replaced

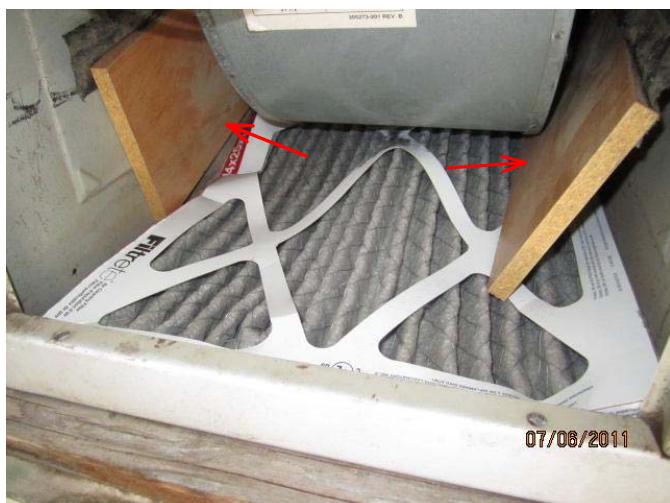
#39 Proper filter hold down straps should be used

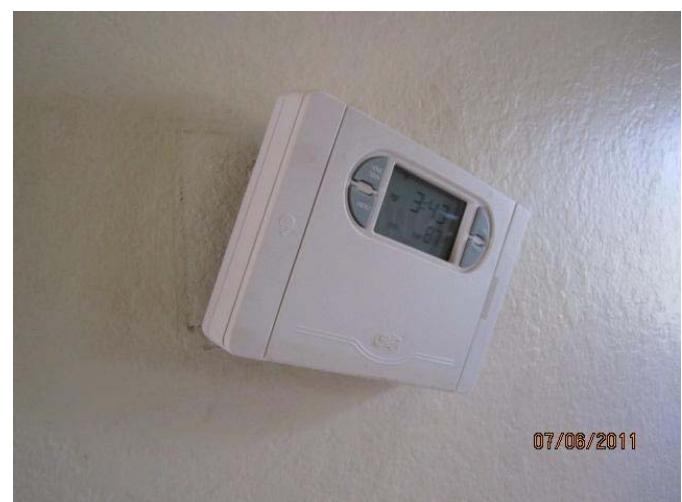
18. Thermostats: Wall mounted **Thermostat is loose**

#42 Thermostat is loose

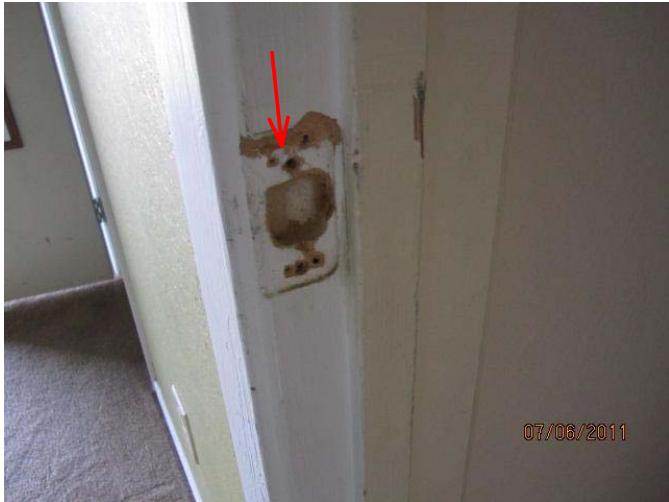
6. Walls: Painted drywall **Drywall cracks noted**
7. Doors: Hollow wood **Missing door hardware**
8. HVAC Source: Heating system register **Vent covers are not secured**
9. Bathroom Counter Tops: Composit Counter tops need to be re-sealed

#45 Missing door hardware

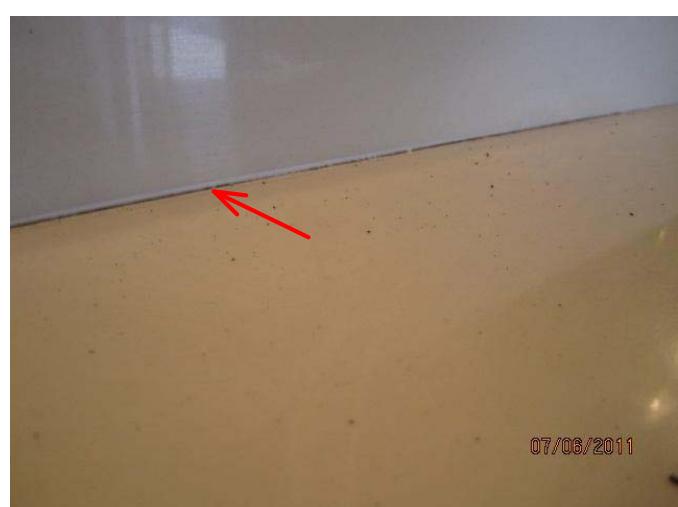
#48 Counter tops need to be re-sealed

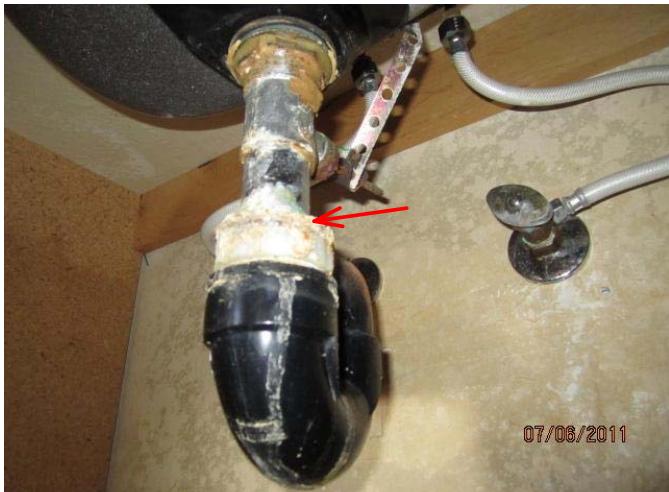
#49 Sink drain connection is corroded and cracked

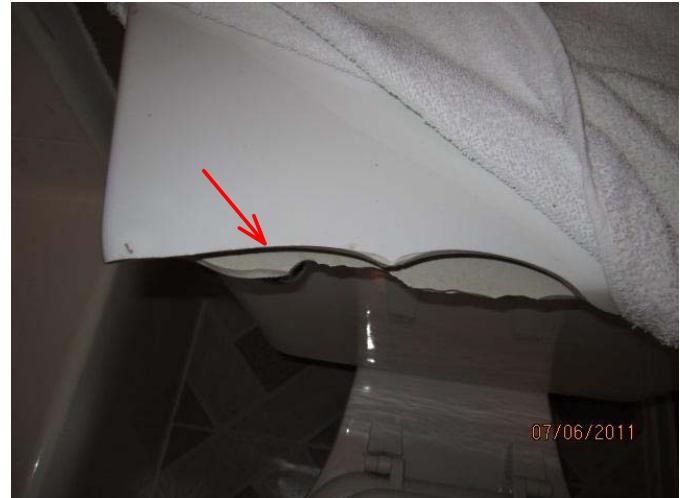
#52 Toilet tank lid is cracked

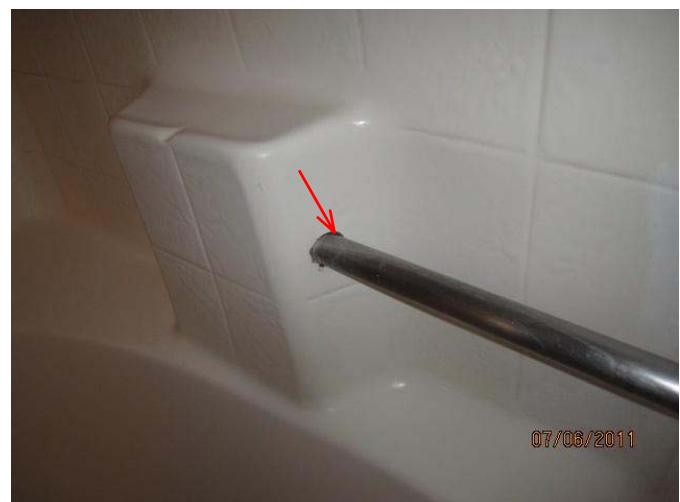
#54 Shower grab bar needs to be sealed

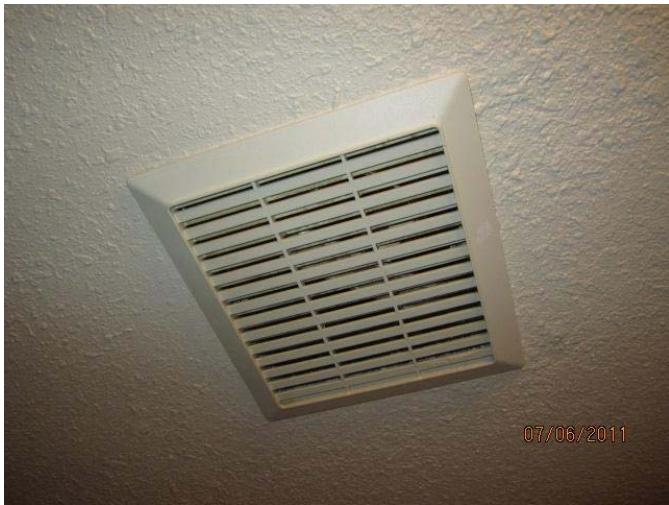
#55 Electric vent fan does not work

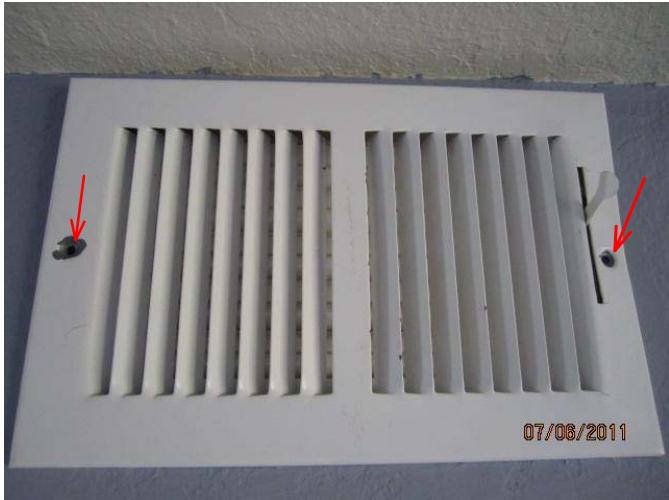
#61 Vent covers are not secured

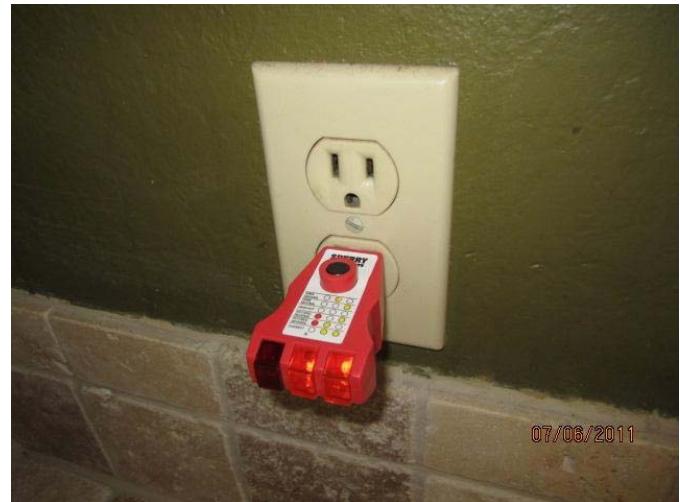
#68 No GFI in kitchen

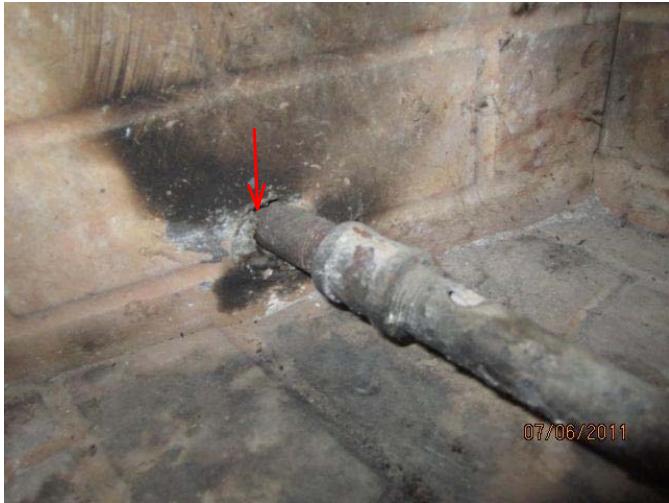
#79 Gas port needs to be re-sealed
